# DECADE PERFORMANCE OF A ROOF-MOUNTED PHOTOVOLTAIC ARRAY

## ABSTRACT

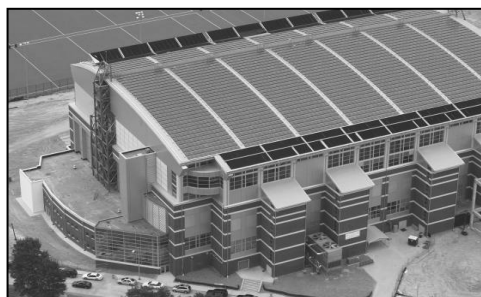
Fig. 1. Aquatic Center Roof-Top PV Array

The 342 kW photovoltaic (PV) system at Georgia Tech's Aquatic Center will have its ten year anniversary in July of this year (2006). When it was first deployed, the array was the largest roof-top PV installation in the world, containing 2,856 multicrystalline silicon modules, with an area of 3175 m<sup>2</sup>. The modules are flush-mounted with the roof of the Aquatic Center, which is curved, giving the modules a tilt range of 13° south-facing to 10° north-facing. Groups of 12 modules are connected in series, called "strings." In total there are 238 strings connected in parallel. This configuration supplies 810 A<sub>DC</sub> at 410 V<sub>DC</sub> (rated values) via seven feeder circuits and a power conditioning unit (PCU) to the Aquatic Center and the distribution network it is connected to.

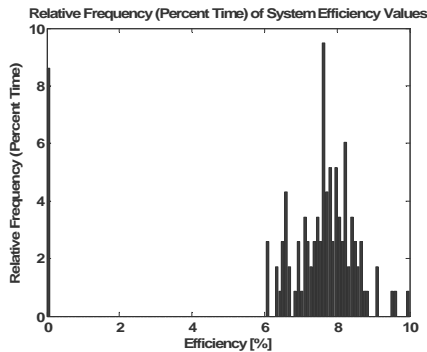
Fig. 5. Histogram of System Efficiency [%].

Relative frequency, or the percent time the system spends at a particular operating condition, of efficiencies is shown in Figure 5 above. It can be seen that the system most often operates within a band of 7-9% efficiency.

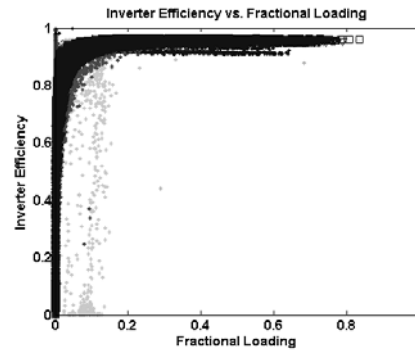
Fig. 6. Inverter Efficiency, as a fraction of nominal power capacity, versus Fractional Loading.

Figure 6 shows inverter efficiency versus fractional loading (the fraction of rated power which the inverter is producing). As is expected, the inverter is more efficient when operating at higher loads. There are several data points that stray from the trend at approximately 0.1

fractional loading. This data is from the year 2001 in which several modules were damaged (stray bullets).

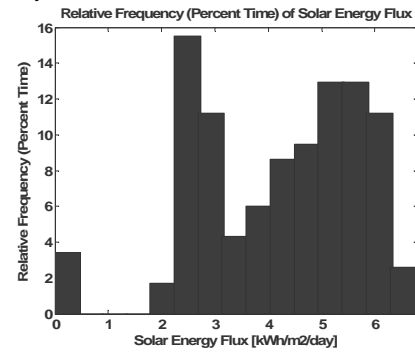
Fig. 7. Histogram of Daily Solar Energy Flux (in kWh/m<sup>2</sup>/day) for Lifetime of the Installation.

From Figure 7 below, the solar energy flux on the roof of the Aquatics Center is most often between 2 to 3 kWh/m<sup>2</sup>/day, and next most often between 5 and 6 kWh/m<sup>2</sup>/day.

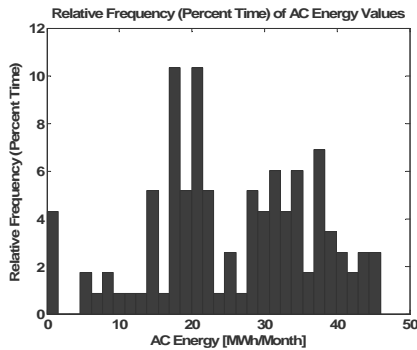
Fig. 11. Histogram of Monthly AC Energy for Lifetime.

Figure 11 below shows how often the PV system produces various monthly AC energy values. This is broken down to hourly AC energy values for the first year of operation, and for the year 2005 in Figure 12. This figure shows zero AC energy production to be most frequent due to non-daylight hours. The first year of operation produced a total of 332 MWh of energy where the year 2005 produced 353.6 MWh.

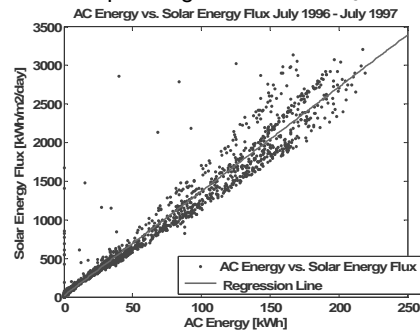
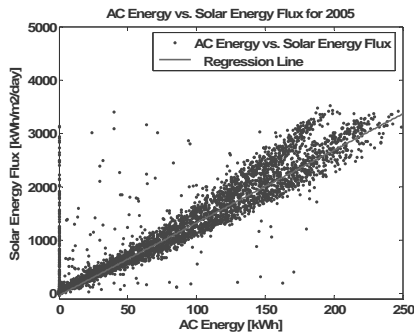
Fig. 16. Daily AC Energy in kWh vs. Daily Solar Energy Flux in kWh/m<sup>2</sup>/day in the First Year of Operation.

Fig. 17. Daily AC Energy in kWh vs. Average Daily Solar Energy Flux in kWh/m<sup>2</sup>/day for 2005.

AC energy versus solar energy flux are plotted in Figures 16 and 17 for the first year of operation and for the year 2005 respectively.

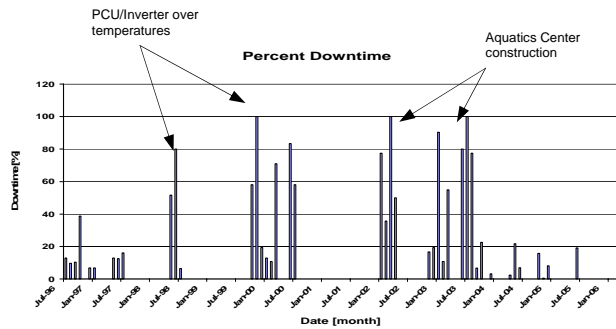
Figure 19: Monthly Percent System Downtime.

Figure 19 illustrates system downtime in percent per month since the commissioning of the system. Arrows point to times when there were PCU/inverter over temperatures, and for times when there was building construction.

From the above table, the most dominant reason for downtime is construction at the Aquatics Center. In 2003 the building was enclosed, which took the system down for a significant amount of time. The PCU/inverter over temperatures occurred because of a broken fan. It can also be seen that the power electronics is a vulnerable part of the system.
